# FATIGUE BEHAVIOUR OF A ROLLED AZ31 MAGNESIUM ALLOYS PREPARED BY EP AND BB CONDITIONS

Abstract: Rotating bending fatigue tests have been performed using smooth specimens of a rolled AZ31 magnesium alloy in laboratory air at ambient temperature. Fatigue strength and characteristic was evaluated and fracture mechanism was discussed on the basis fracture surface analysis. Electrical polishing (EP) as well as deep rolling (ball burnishing (BB)) U-notched specimens were performed on two groups of samples, to evaluate optimum conditions for fatigue life. The microstructure and tensile properties of roll cast (RC) Mg- 3% Al- 1% Zn (AZ31) was investigated. The fatigue strength of 107 cycles around 100 MPa for deep rolling while it was around 40 MPa for Electrical polishing. It was very important to understand the effect of (ball burnishing (BB)) conditions on the hardness of the surface through to the core. The two procedures improved the fatigue performance, but better improve in results were found in ball burnishing. The growth of small cracks initiated at the surface coincided with the FCP characteristic after allowing for crack closure for large cracks, but the operative fracture mec

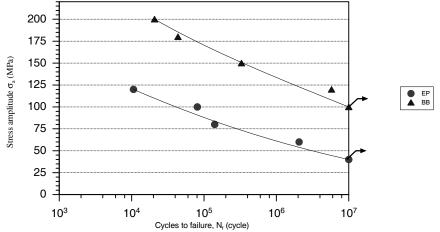
Fig.2. S-N curve for rolled AZ31 at EP,BB conditions, rotating beam, R=-1, 50Hz.

S/N curves for the EP and the BB specimens in laboratory at a stress ratio of -1 and frequency of 50 Hz (rolled magnesium alloy) in laboratory air is shown in Fig. 2. In this figure, for comparison purposes, the S-N curves of the EP and BB specimens are shown respectively. As seen from the figure, the fatigue life of the rolled magnesium alloy of EP specimen is relatively shorter than that of BB specimen. The extent bending in the S-N curve is gentler in the BB specimens than in the EP specimen. Next let us compare the S-N characteristics of the EP and BB specimens. There are great differences in the fatigue lives and in the fatigue limits, especially at higher stress amplitudes, there are differences in the fatigue lives.

4. Subsurface crack initiation occurred at applied stresses at 60 MPa. At BB condition but it can be seen for both 80 and 100 MPa stress for EP condition. The S–N diagram is shown in Fig. 2. It is well known that fatigue limit does not exist in non-ferrous alloys, thus fatigue tests were continued until  $10^7$  cycles. At EP condition  $\sigma$ = 40 MPa, fatigue failure did not occur, but non-propagating cracks were observed on the specimen surface. As can be seen in the figure, the present Mg alloy seems to possess a definite fatigue limit, which may be related to the existence of non-propagating cracks. The fracture mode depending

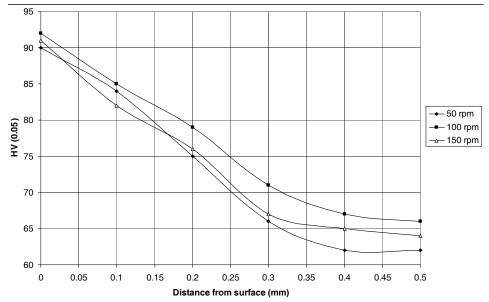
Fig. 3. Microhardness profile oif AZ31 after BB at 200 bars, 0.17 mm/min at different BB rotation speed.

**3. 3.** A different experiment were used to investigate the best condition for BB (pressure, feed rate, speed) as example for tool HG3 200 bar (123 N) for 50, 100 and 150 rpm. The microhardness measurement from the surface in Fig. 3. Shows that the suitable condition for using 200 bars is 100 rpm for AZ31 as the hardness decreased from the circumference gradually to the center.

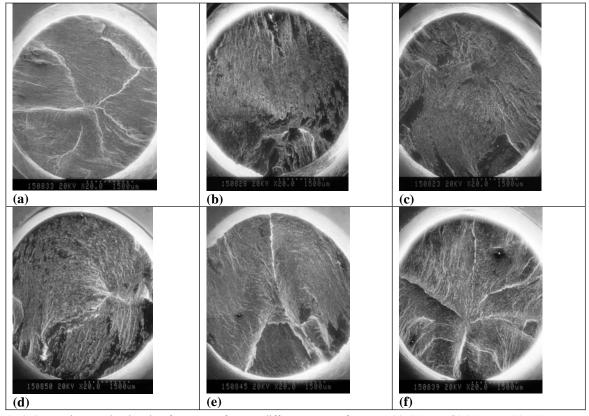
**Fig.4.** SEM micrographs showing fracture surfaces at difference stress for EP at (a) 60MPa; (b) 80 MPa; (c) 100 MPa and BB at (d) 60MPa; (e) 80 MPa; (f) 100 MPa.

The fracture surface of AZ31 for EP condition and BB condition at different stress is shown in Fig.

on applied stress level, above 60 MPa cracks initiate at the surface (surface fracture), while below that stress at the interior of the specimen (subsurface fracture). Subsurface fracture is a very interesting finding, which has not been recognized in Mg alloys, for both EP and BB conditions.

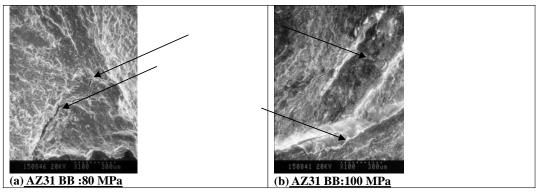
Fig. 5. SEM micrographs showing cracked surfaces at difference stress for BB at (a) 80MPa; (b) 100 MPa

The cracked line could be seen easily for higher stress for BB condition as fracture occurs in internal surface not at the outer surface as in the EP condition in Fig. 5.
