# FATIGUE BEHAVIOUR OF A ROLLED AZ31 MAGNESIUM ALLOYS PREPARED BY EP AND BB CONDITIONS

**Abstract:** Rotating bending fatigue tests have been performed using smooth specimens of a rolled AZ31 magnesium alloy in laboratory air at ambient temperature. Fatigue strength and characteristic was evaluated and fracture mechanism was discussed on the basis fracture surface analysis. Electrical polishing (EP) as well as deep rolling (ball burnishing (BB)) U-notched specimens were performed on two groups of samples, to evaluate optimum conditions for fatigue life. The microstructure and tensile properties of roll cast (RC) Mg- 3% Al- 1% Zn (AZ31) was investigated. The fatigue strength of 107 cycles around 100 MPa for deep rolling while it was around 40 MPa for Electrical polishing. It was very important to understand the effect of (ball burnishing (BB)) conditions on the hardness of the surface through to the core. The two procedures improved the fatigue performance, but better improve in results were found in ball burnishing. The growth of small cracks initiated at the surface coincided with the FCP characteristic after allowing for crack closure for large cracks, but the operative fracture

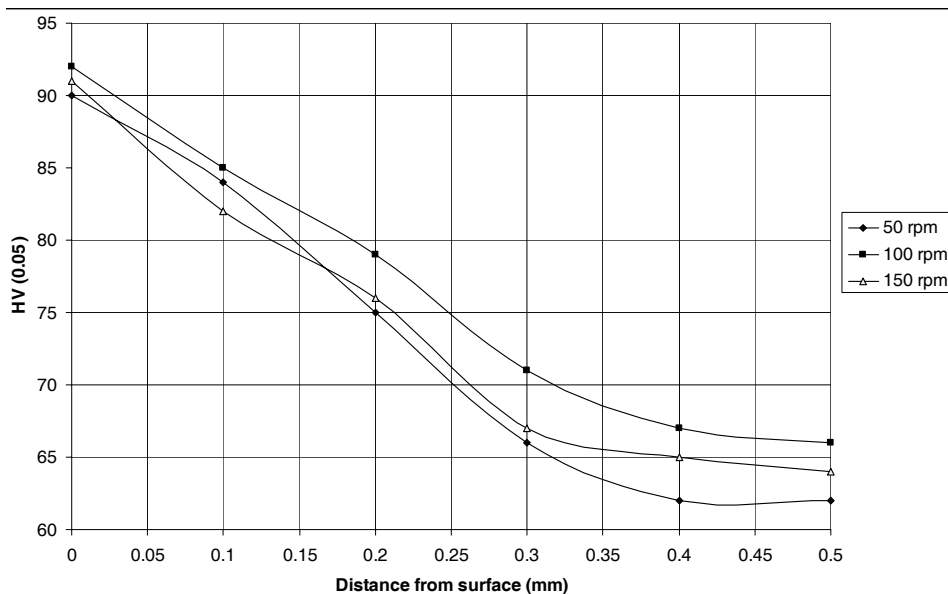
**Fig. 3.** Microhardness profile of AZ31 after BB at 200 bars, 0.17 mm/min at different BB rotation speed.

**3. 3.** A different experiment were used to investigate the best condition for BB (pressure, feed rate, speed) as example for tool HG3 200 bar (123 N) for 50, 100 and 150 rpm. The microhardness measurement from the surface in Fig. 3. Shows that the suitable condition for using 200 bars is 100 rpm for AZ31 as the hardness decreased from the circumference gradually to the center.
