EFFECT OF HEAT INPUT ON THE STRUCTURE AND PROPERTIES OF ALUMINIUM WELDMENT

Abstract: The probable reasons for evolution of weld porosity and solidification cracking and the structure-property relationship in aluminium welds were investigated. Aluminium plates (1xxx series) were welded by Tungsten Inert Gas (TIG) welding process, 5356 filler metal was used and heat input was controlled by varying welding current (145A, 175A and 195A). The welded samples were examined under optical and scanning electron microscopes and mechanical tests were performed to determine tensile and impact strengths. Secondary phase, identified as globules of Mg_2Al_3 precipitates, was found to be formed. Solidification cracking appeared in the heat affected zone (HAZ) and porosities were found at the weld portion. The tendency for the formation of solidification cracking and weld porosities decreased with increased welding current.

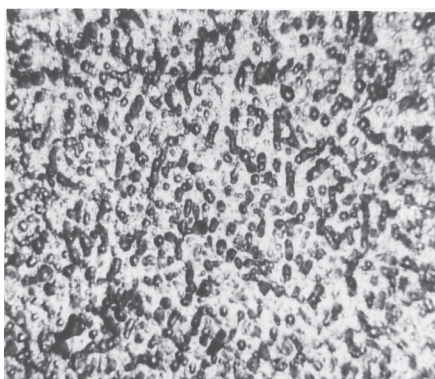
Fig. 4(c). Micrograph of plate 2 (root)

The Mg_2Al_3 precipitates are more concentrated (Fig. 4(c)) in the weld root than in the weld portion (Fig. 4(b)). This is because of higher rate of heat dissipation at the root of the weld. During

welding, root pass is performed first and during solidification of this root portion heat can dissipate from all sides. So root portion cools rapidly. But the following weld passes have slow heat dissipation rate. Because during those passes, root and base metal are already preheated that slows down the cooling rate.
