# Dry Sliding Friction and Wear Resistance of SnPb-Solder Affected Copper against Stainless Steel Counter Surface

**Abstract:** This paper reports the wear behavior of Cu, high Cu-Sn alloy, high Cu-Pb alloy and high Cu-Sn-Pb alloy under dry sliding at ambient conditions. These four materials were chosen for the wear resistance characterization of SnPb-solder affected old/scraped copper (high Cu-Sn-Pb alloy) to explore its reusing potentials. Wear tests were conducted using a pin-on-disk tribometer with the applied load of 20 N for the sliding distance up to 2772 m at the sliding speed of 0.513 ms<sup>-1</sup>. The applied load was also changed to observe its effect. The investigation reveals that the presence of a small amount of Sn increased the hardness and improved the wear resistance of Cu, while a similar amount of Pb in Cu reduced the hardness but improved the wear resistance. The general perception of 'the harder the wear resistant' was found to match partially with the results of Cu, Cu-Sn alloy and Cu-Sn-Pb alloy. Coefficient of friction (COF) values revealed non-linear gradual increasing trends at the initial stage and after a certain sliding distance COF values of all f

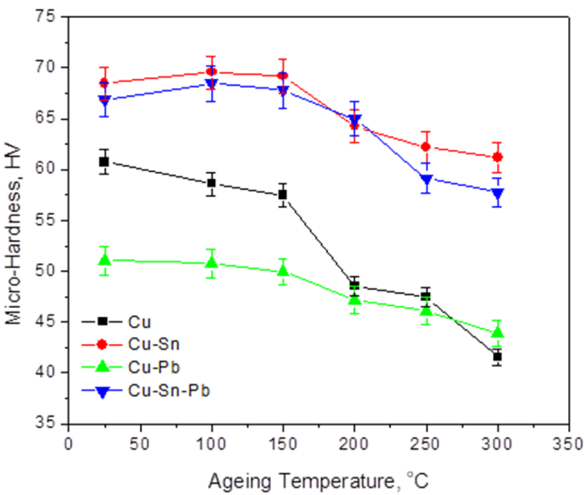
Fig. 1 shows the changes in micro-hardness

values of sample materials after isochronal ageing for 60 minutes at different temperatures. Once the isochronal ageing is done at 25°C, 100°C or 150°C, the changes in micro-hardness values are very negligible. Therefore, all four sample materials can be considered sustainable comfortably with respect to hardness up to the operating temperature of 150°C. But, while the ageing is done at elevated temperatures like 200°C or above, the micro-hardness values of sample materials have been found to be significantly reduced. The reason behind such reduction in micro-hardness for the thermal ageing at a higher temperature is the recrystallization effect. The dislocations of the crystalline structures of copper based materials have got affected during thermal ageing above the recrystallization temperatures. As a result, the micro-hardness values of sample materials for the ageing temperature of 300°C are reduced to 41.55 HV, 61.16 HV, 44.89 HV and 57.72 HV, i.e., reduced by 31.5%, 10.6%, 12.1% and 13.7% from their as-cast values, respectively. After ageing at 300°C temperature, Cu-Sn alloy depicts to be the hardest, which is followed by Cu-Sn-Pb alloy and thereafter CuPb alloy.

Fig. 1. Micro-hardness of sample materials against isochronal ageing temperature while aged for 1 hour.

At this condition, the lowest hardness is observed for pure Cu with a significant loss of its compressive strength. Fig. 1 also indicates that alloys are less affected than pure copper on hardness by ageing at elevated temperatures. It exhibits high softening resistance due to the solid-solution strengthening of the alloys. The change of micro-hardness with respect to ageing temperature for both pure Cu and high Cu alloys can be considered as an effect of atomic diffusion in the recovery phase and variation of dislocation density during the ageing at elevated temperature for copper based materials [6, 23, 24].

The hardness results (shown in Fig. 1 and 2) and the wear results (Fig. 3 and 4) agree with a common understanding on 'the harder has the lesser wear' partly for alloys. Because the specific wear rates of both harder alloys (Cu-Sn alloy and SnPb-solder affected Cu) and softer alloy (Cu-Pb alloy) have been found to be lesser than that of pure Cu, and it disproves the universal acceptance of reverse proportionality of wear rate against hardness. However, solder affected copper has shown a moderate position amongst the four materials and it may be considered suitable to use for machine parts having sliding motions. Furthermore, Fig. 4 demonstrates a certain level of wear rate sensitivity over the sliding distance covered during the experiment, and the wear rates are found to be increased against the sliding distance. It might be the reason of adhesion occurring at the asperity contacts in the interface resulting in the detachment of a fragment from one surface and might get away or attached to the other surface. As the sliding process continues further, the fragments that have transferred to the other surface might also be finally removed as loose wear particles.
